# ***Archbold Road, Eastern Creek: Groundwater and Salinity Assessment for Proposed Quarry Rehabilitation Project and Developable Land***

Light Horse Business Centre

BJ07/Rp010 Rev E  
May 2007 Update

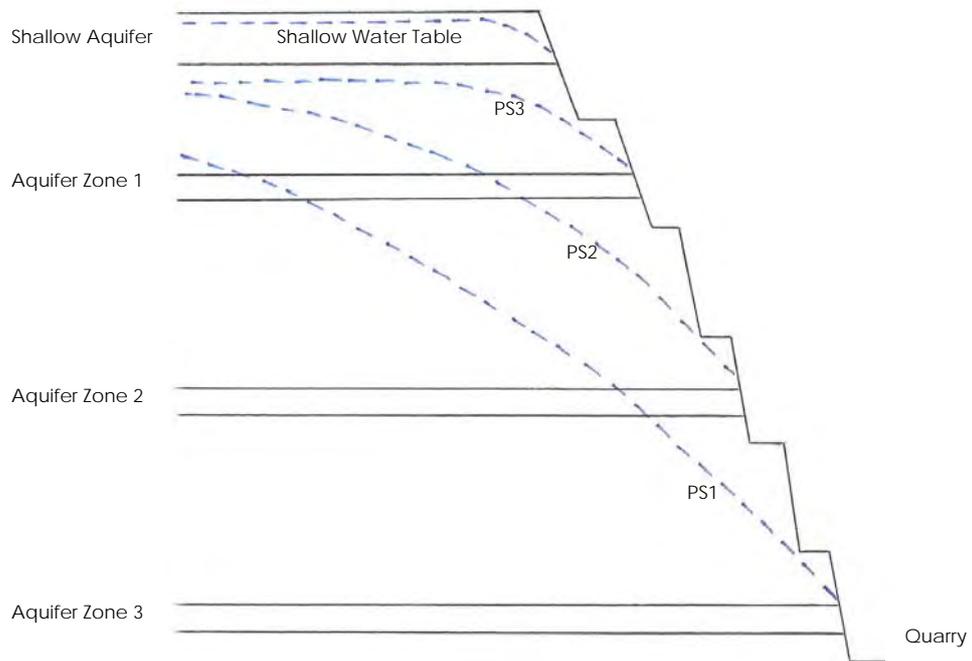
Figure 3.3: Conceptual Groundwater Regime (Simplified, not to scale)

The low permeability of the strata in and around the quarry mean that depressurisation is likely have resulted in a steep drawdown cone. The extent of depressurisation is likely to be fairly limited in the shallow aquifers within the soils/weathered profile and upper shale, but may extend to a kilometre or more from the quarry in the deep aquifers. The conceptual groundwater regime around the quarry is illustrated in *Figure 3.3*.

Observations made by quarry staff are that seepages generally occur immediately after rain and persist for a few days to a few weeks. There are some areas of permanent seepage, although the inflow rates from these are reportedly low. In general seepage is greatest from the north-eastern quarry face, and lowest in the western area. This suggests that the permeability of the remaining igneous body is relatively low.

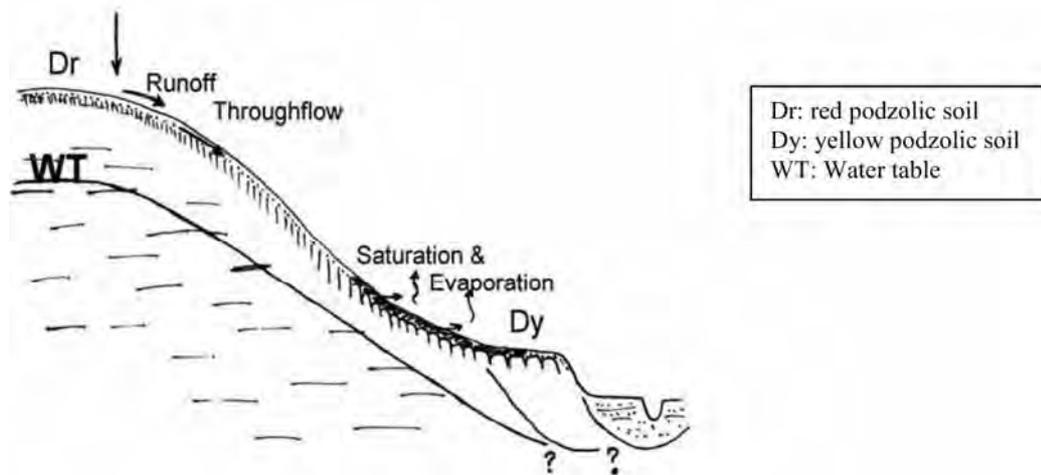
Figure 3.4: Salinity Associated with Shale Soil Landscape (Mitchell, 2000)

Soil landscapes in Western Sydney commonly comprise poorly drained duplex soils, with a relatively permeable loamy topsoil over a low permeability clay subsoil, and this situation is likely to prevail across most of the site. Soil water moves more easily through the loamy topsoil (often flowing across the underlying clay), and salt can accumulate in the subsoil. Surface expression of salinity occurs where soil water accumulates and seeps to the surface, and evaporation concentrates the salts; typically on lower slopes or flats (Nicholson, 2003). This situation is shown in *Figure 3.4*.

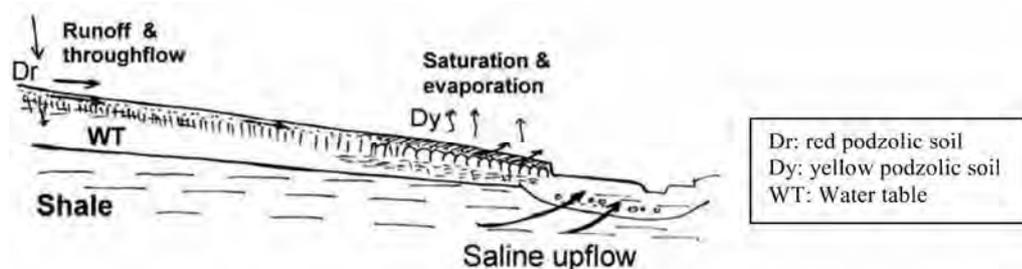
Figure 3.5: Salinity Associated with Deep Groundwater Discharge (Mitchell, 2000)

Salinity can also arise in areas of saline groundwater discharge from deeper aquifers. Groundwater in the Bringelly shale is typically brackish to saline, and this water discharges naturally along creeks and gullies. Salinity expressions occur in discharge zones and when groundwater is sufficiently shallow for capillary action to bring water and salt to the surface. These effects are exacerbated should groundwater levels rise due to increased recharge accompanying vegetation removal and landuse changes etc. This situation is shown in *Figure 3.5*.

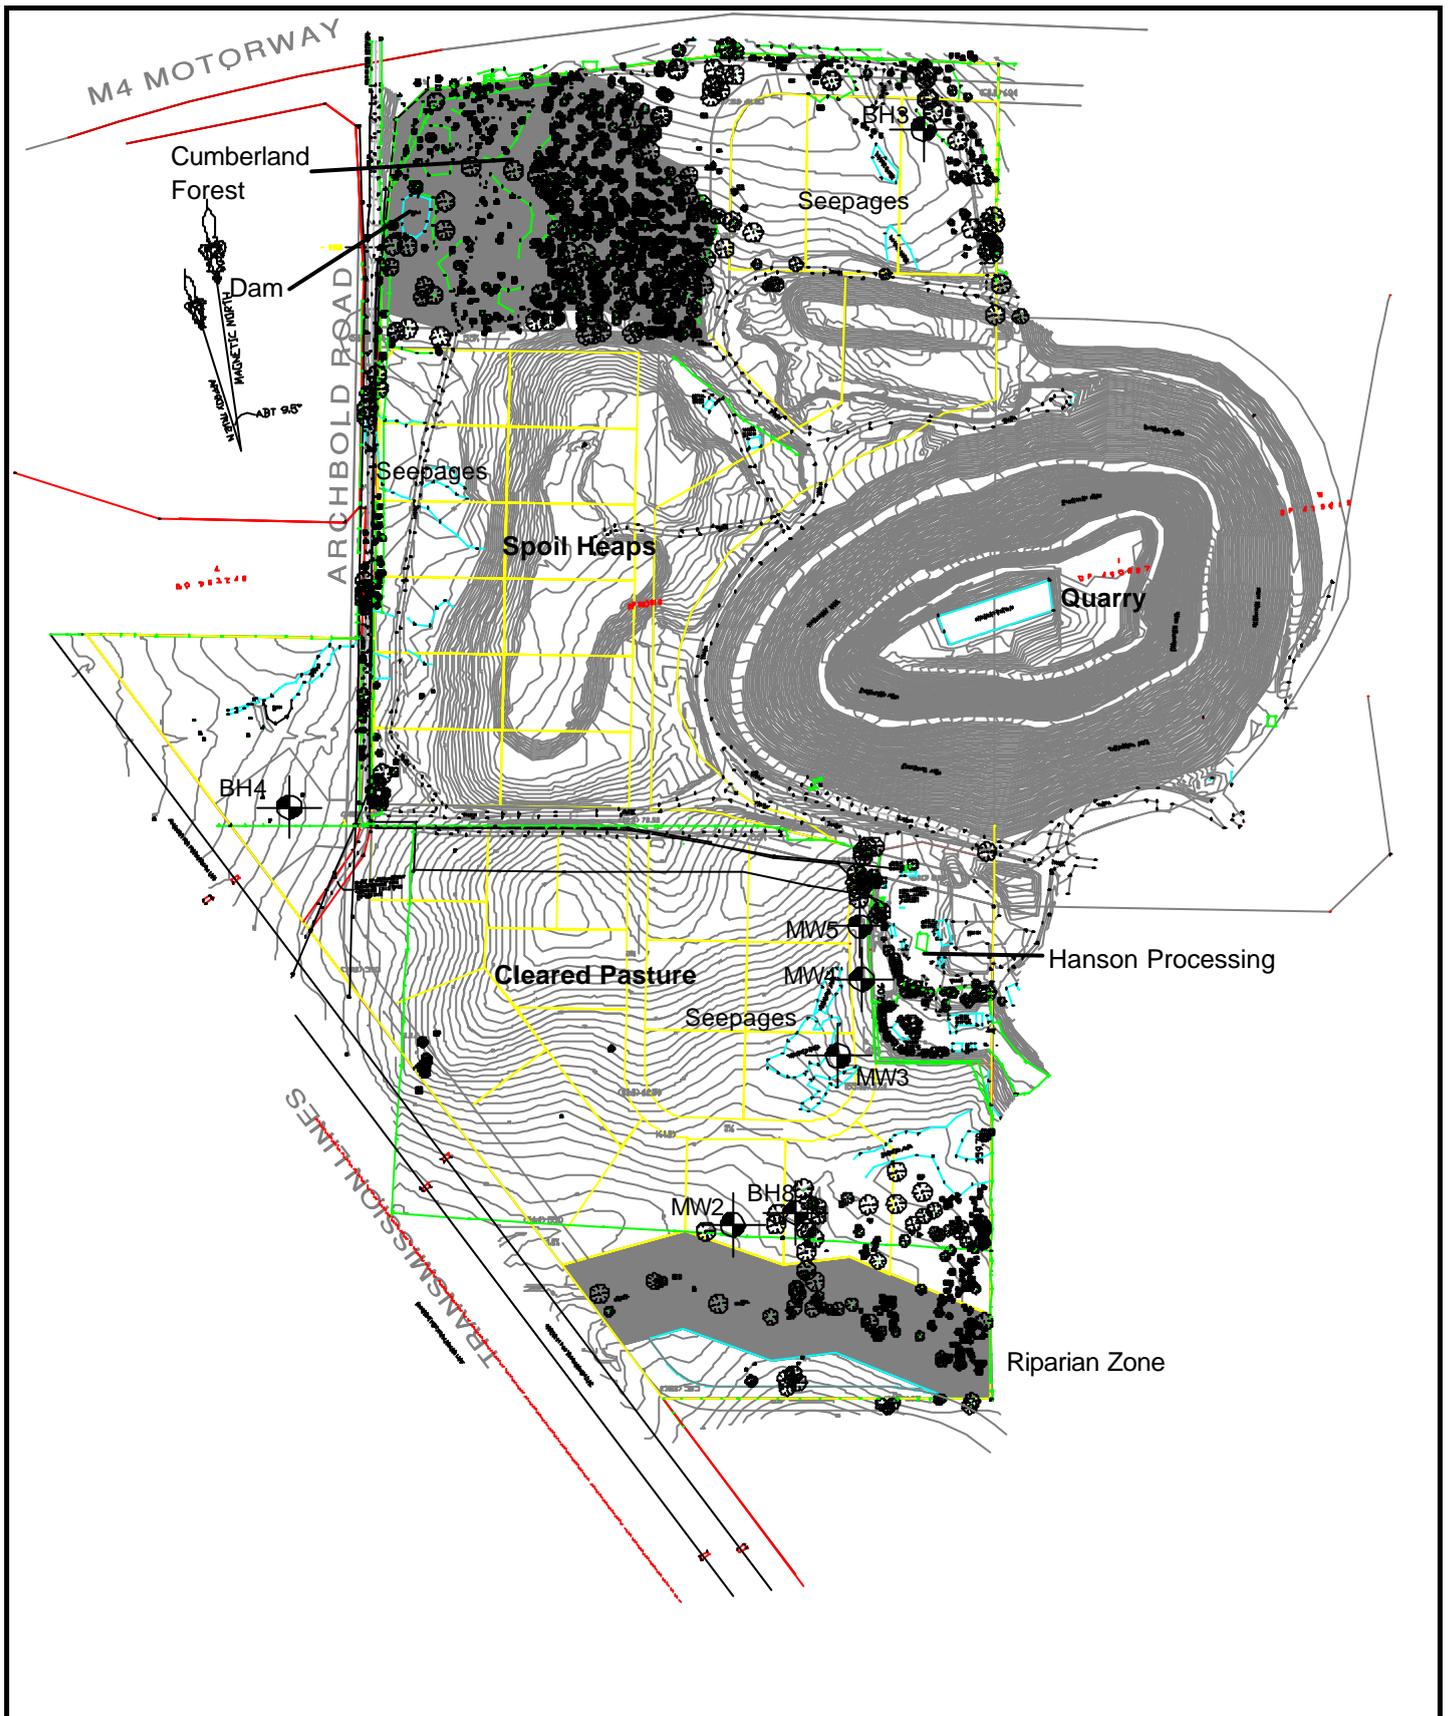
**FIGURE 3.1: Site Features**

The main surface water feature in the area is Ropes Creek, located approximately 400 metres west of the site boundary. A gully (minor tributary of Ropes Creek) runs east to west across the cleared farmland that forms the southern part of the site. Excess water pumped from the quarry has been discharged to this gully for around 40 years, and this will probably have changed the character of the gully considerably. The gully is presently in a fairly degraded condition, with erosion features evident along the banks. Two or more other minor drainage lines cross the cleared land west of Archibald Road (both within and outside of the proposed development site). These would originally have had some expression on the site but are assumed to have been obscured by spoil heaps.

A number of minor seepages or wet areas were evident during the site inspection. Those in the cleared farmland west of the Hanson processing area are likely to reflect seepage from nearby dams. The wet areas between the spoil heaps and Archbold Road are likely to be due to obstruction of runoff drainage lines by spoil heaps, site roads and Archbold Road. They may be exacerbated by seepage of accumulated infiltration within the spoil heaps.

No evidence of serious salinity impacts was observed: there were no indications of salt scalds, salt crystals, vegetation dieback or other salinity effects. Several areas of waterlogging were observed as discussed in *Section 3.3*: however these appear to be associated primarily with leakage from dams or poor surface water drainage. Placement of spoil heaps will have increased infiltration of rainfall, and both the presence of spoil heaps and construction of site roads have impeded surface water drainage, and these factors have exacerbated waterlogging on the north-western area of the site.
